CC430F6147 Device Erratasheet

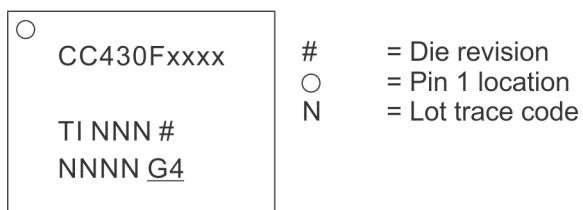
RGC64

QFN (RGC), 64 pin

The revision of the device can be identified by the revision letter on the [Package Markings](#) or by the [HW_ID](#) located inside the TLV structure of the device
